# Geosynthetics Applications and Performance Reviews

## Select Case Histories

## Five Case Histories

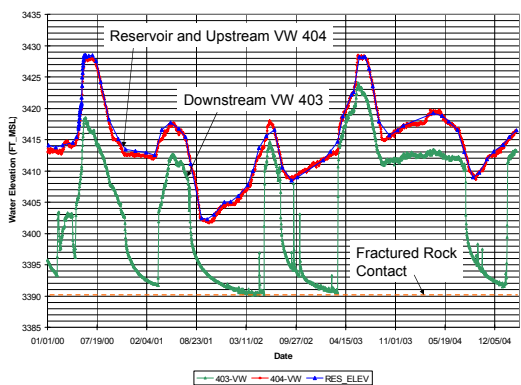
Tongue River Dam - Piezometers Left Side of Spillway

- ◆ Piezometric data are inconclusive with regard to barrier performance
  - ◆ “End-around” seepage into the fractured rock unit from west causes rapid rise and fall in water levels as the wedge clinker unit in front of spillway foundation “fills up” then empties. This is being tracked by Piezo 403, and indicates a direct hydraulic connection with the fractured rock unit.
  - ◆ One VW instrument downgradient from the barrier east of spillway (406) may be malfunctioning and needs to be replaced

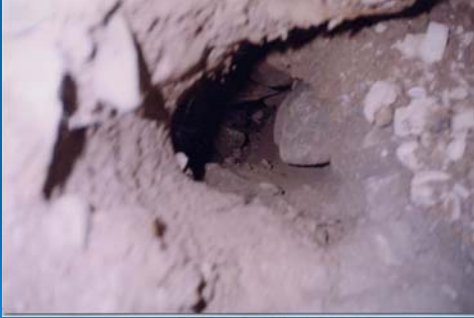
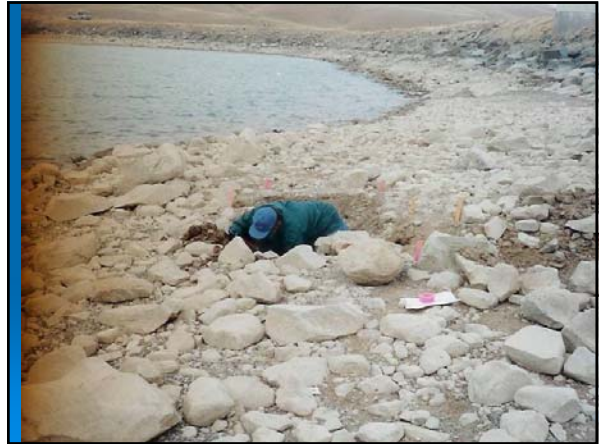
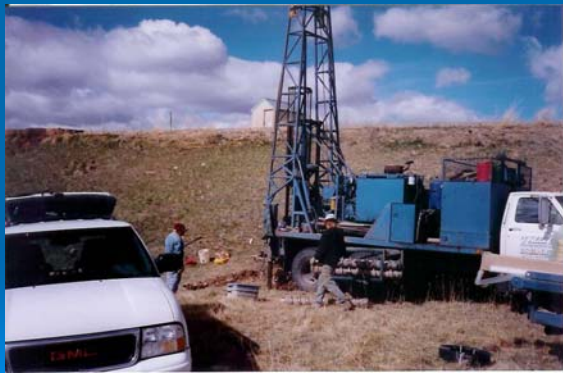
### Partially Excavated “Pipe”

- Depression and piping features were caused by downward erosion of fines from glacial soil matrix into a pocket of openwork boulders and cobbles
- Surficial soils had provided an effective impervious blanket over the area until progressive wave action eroded the natural clay "lining".
- The shallow boulder pocket in the right abutment appeared to be limited in extent, based on the drilling information.
