GEOSYNTHETICS APPLICATIONS AND PERFORMANCE REVIEWS – SELECT CASE HISTORIES

Summary

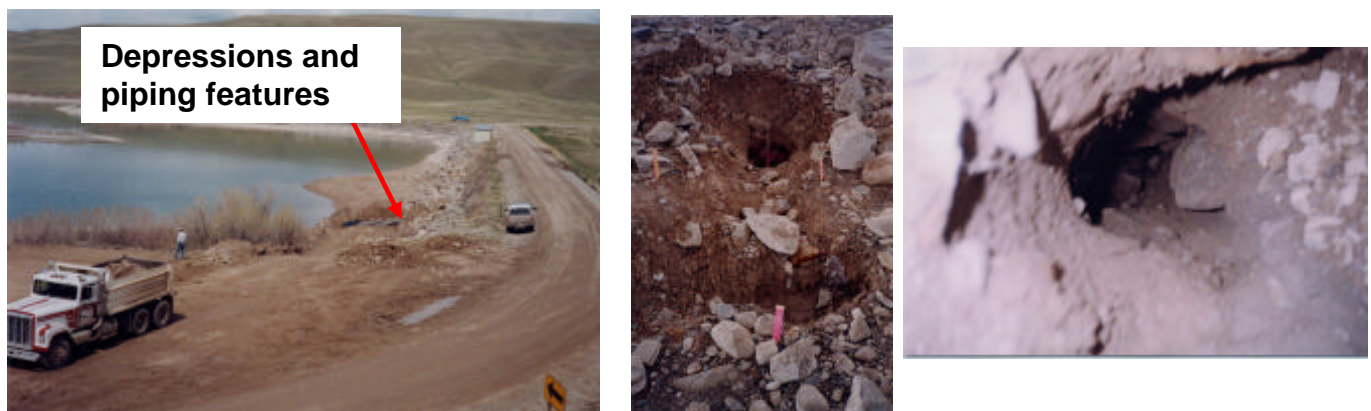
Test pit investigations in the immediate vicinity of the depression found several deep erosion “piping” features that had formed in the surficial, fine-grained materials, some up to 12-inches in diameter (Figure 1). These pipes appeared to trend vertically downward.

Figure 1. Surface Depressions and Vertical Piping Features at Nilan East Dam

The main interpretation from the site investigation was that the depression and piping features had been caused by downward erosion of fines from the glacial soil matrix into a pocket of openwork boulders and cobbles in the right abutment of the dam. The surface soils had evidently provided an effective impervious blanket over the area until progressive wave action eroded the fine-grained "liner" sufficiently that a hole eventually broke through to the underlying nest of large boulders under the downward seepage gradient. Severe wave erosion was, in fact, evident all around the entire reservoir rim near normal pool elevation. Downward seepage of reservoir water towards the deeper pervious zone had evidently piped fine grained soils from the glacial till matrix into the underlying pocket of open-work boulders and gravels. Test pits in this area were very difficult to excavate due to the presence of very large boulders. However, the area seemed very limited in extent, as verified by test pits adjacent to the depression and downstream from the dam. The exposed area essentially acted as a vertical drain to the permeable zone located at depth in the foundation.

The selected remedy was to construct a "patch" to repair the natural reservoir "liner" that had been removed by wave erosion. The recommended solution incorporated geosynthetics to provide a high strength, low permeability system that could be expeditiously constructed. The following is a simplified description of the completed work:

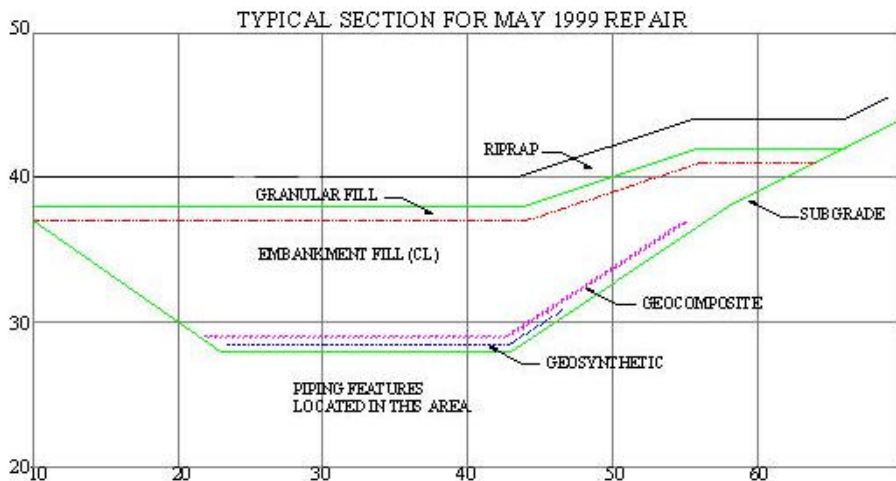
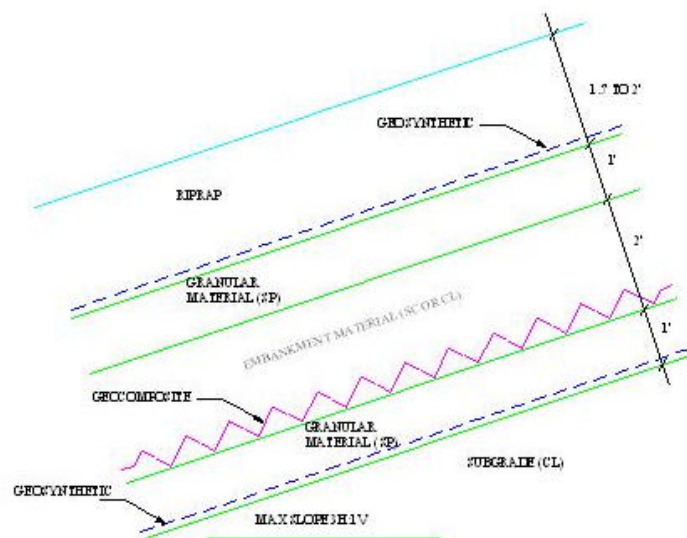
Figure 2 shows the typical as-built cross section of the liner system. This first repair was limited in aerial extent because of working constraints between the high reservoir pool at the time, and the dam embankment. The overall area repaired was about 2700 square feet. The work was completed within four weeks during May, 1999.

Figure 2. Typical cross sections of geosynthetic patches used at Nilan East Dam

1. The geotextile and geocomposite (GCL) materials were separated by 1-foot of granular material. The layer of granular material was placed to serve three functions: (1) it provided an increase in interfacial shear strength as opposed to placing the materials directly against each other; (2) the geotextile was sized to meet filter criteria, thus keeping the granular material from piping thru should a void form under the fabric; and (3) the granular material will act as a filter for the GCL, should there be any excessive hydrostatic gradients acting on the liner.

2. Based on results from a 2-dimensional seepage analysis, the GCL placement on the north, south and west repair edges was keyed in to force a longer seepage path at the liner's edge.
3. The GCL and geotextile were keyed in at the dam face and edges of the first repair to provide stability.
4. The overall area excavated was shallower than the previous repair. The excavation depths were between 4 and 6 feet deep.

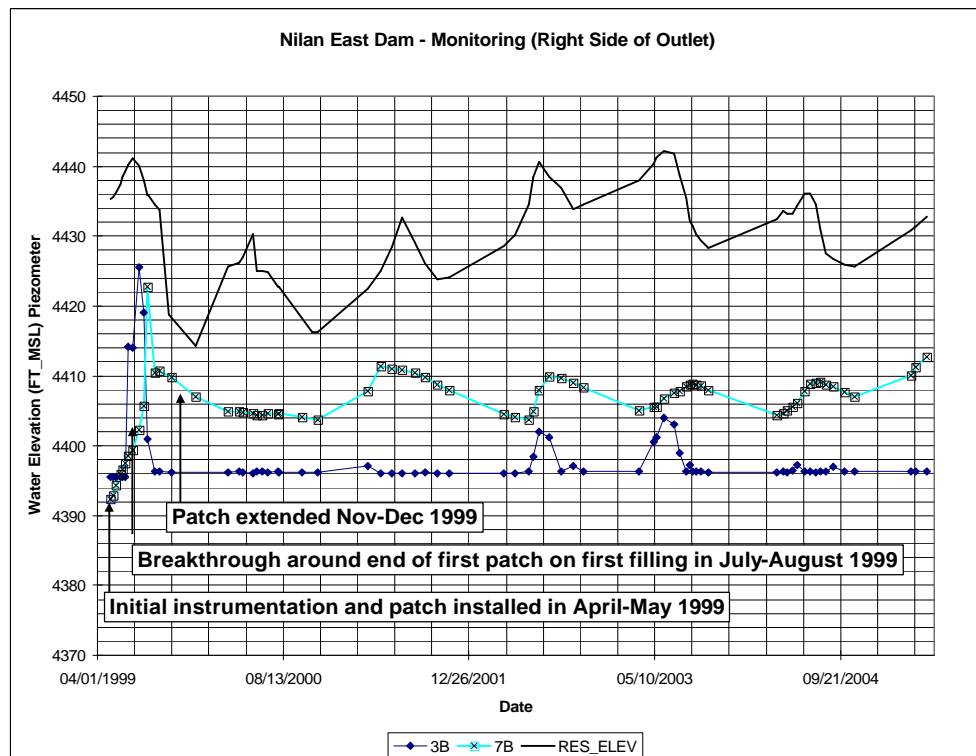
Figure 3 shows readings for select piezometers that were installed in the vicinity of the patched area. The rapid rise in piezometric levels in the summer of 1999 was an indication that the piping features had broken through around the edge of the patch and connected to the gravelly zone at depth. This occurred after the initial patch was constructed and the reservoir level rose above the patched area for the first time. After the patch was extended in November and December 1999, the measurements show that the wells have been trending normally with the reservoir levels, and the repair appears to be functioning well.

While this repair has seemed to function properly for the past 6 years, it does have limitations. There is still a possibility of seepage forcing a path around the edges of the liner and finding an existing piping feature. Also, this liner does not extend across the entire dam face and around the intake structure. Counteracting these concerns, the surficial clayey materials in these locations are relatively thick, and are protected from the wave and wind erosion that removed the surface materials where the original pipes formed.

Figure 3. Piezometer Data for Nilan East Dam

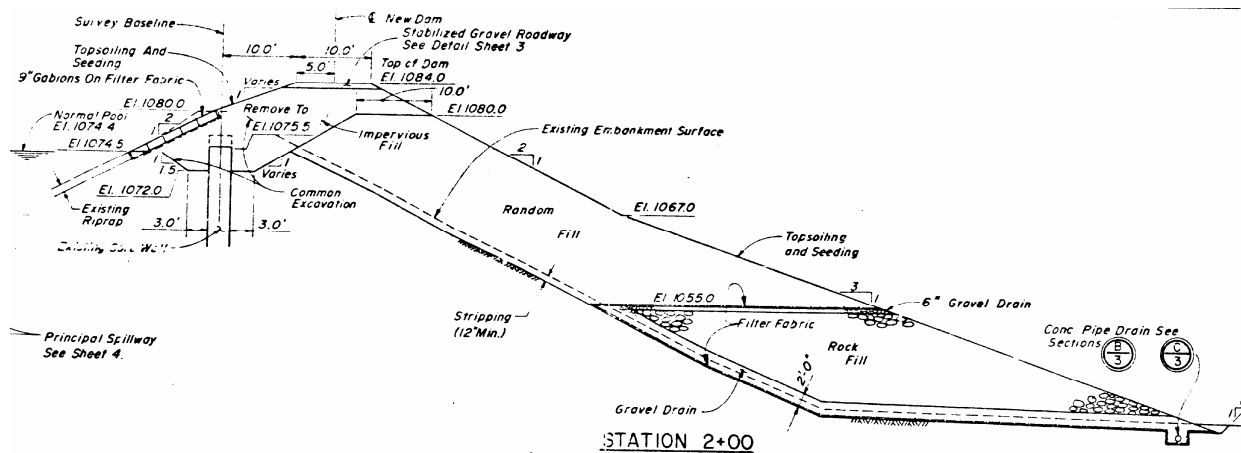
Figure 4. Gardner Creek Dam Embankment Raise Section, Showing Filter Fabric Installation

Records of annual inspections at the dam (1, 2) do not include any observations of discharges from the trench drain that was constructed at the toe of the rock fill. Construction drawings (3) show the drain outlet location at the right side of the spillway channel, but drain discharges have not been mentioned in any of the field inspection reports to date. However, a minor seep has been observed in close proximity to the blowoff pipe outlet. The observed seepage has been clear. This suggests that seepage has been occurring and continues to occur along the outlet works pipelines. The trench drain located along the perimeter of the rockfill was not designed to intercept seepage that occurred along the outlet works pipelines. Piezometer records collected in 2003 (4) show that piezometric levels within the embankment near the cutoff wall are near the bottom of the blanket drain. This may explain the lack of drain discharge observations.

The 1983 embankment raising was accomplished by stripping the downstream slope to a depth of 12 inches and placing zoned fill on the downstream slope of the dam (Figure 4). The fill at the toe of the dam consisted of rock fill that was encased at the top, bottom, and existing dam surface by filter fabric and a gravel filter layer. Filter fabric and gravel filter was also placed on top of the outlet works pipes at the location of the reconstructed valve vault. A trench drain with filter fabric, gravel backfill, and a perforated concrete pipe was installed along the toe of the rock fill. The filter fabric, drain, and rock fill installation was constructed to intercept any embankment seepage and to convey any leakage from the outlet works pipes that might have been occurring at the valve structure. Filter fabric was also used to encase gravel and rockfill blanket drains that were designed to limit hydrostatic loads on the spillway walls (Figure 5).

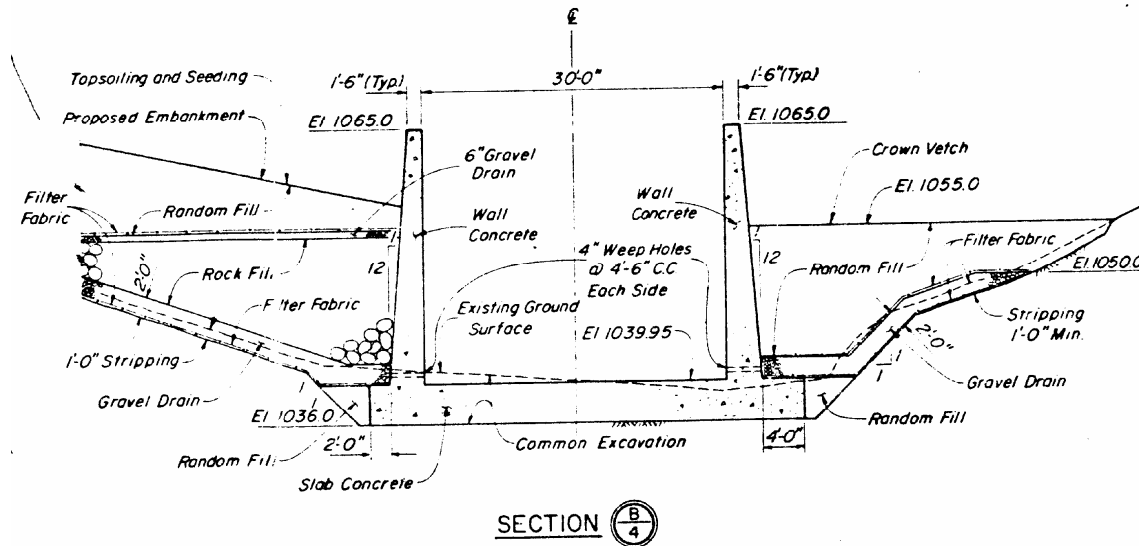
Figure 5. Gardner Creek Dam, Section Through Spillway Walls

Since the replacement spillway has been constructed, no horizontal movement or leaning in the walls has been observed. Minor vertical settlement has been observed, but appears to have occurred primarily within the first five years after construction of the replacement spillway. No new settlement has been observed. Discharges from spillway wall weep holes have not been observed.

Inspection records show that small depressions have formed next to concrete retaining walls in areas where earthen fill was placed on top of filter fabric and rock fill. Exposed filter fabric has been observed at the bottom of these depressions. It is possible that ruptures in the fabric may have occurred in these areas or that earthen materials have flowed through a gap between

the filter fabric and the concrete wall. It is noted that the areas where these depressions have been observed are close to weep holes in the walls. The weep holes are covered on both sides by rock fill, so discharges from the weep holes cannot be observed.

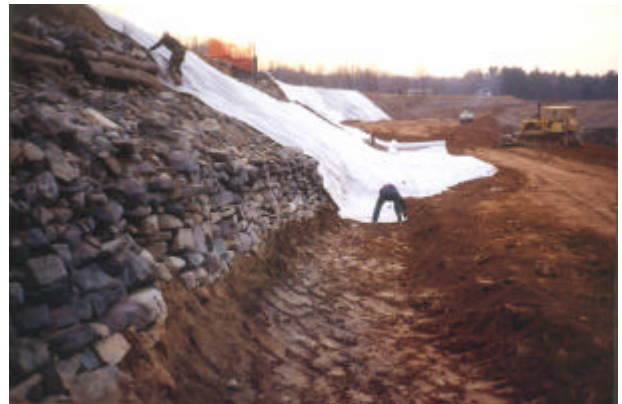
Figure 6. Installation of upstream geotextile seepage barrier

In preparing this paper, Gannett Fleming contacted the Pennsylvania Department of Environmental Protection (PADEP) Dam Safety chief. We learned that the dam is still in service, but that ownership has changed hands since Gannett Fleming's involvement on the project. Additional spillway repair work was constructed in August 2001. Although the structure is still subject to periodic inspections, the PADEP chief did not have specific information on how the embankment and the upstream geotextile lining were performing. The dam is evidently still holding water, indicating that the upstream facing is functioning as intended.

The upstream seepage blanket was a unique application of geotextile in an upstream seepage control function. The design employed a heavy, nonwoven geotextile, laid directly over exposed timber crib/rockfill materials, followed by placement of a locally obtained semi-pervious fill on the upstream side (Figure 6). The fabric, which was a grade normally used for railroad subgrade/ballast separation, was sufficiently robust to withstand the extreme installation conditions, and the opening size was specifically designed to clog with the fine-grained materials placed over the fabric, rather than act as a filter. This system provided a cost-effective, relatively impervious barrier which had sufficient strength and flexibility to span large openings in the face of the existing dam, as well as accommodate any ongoing movements of the structure.

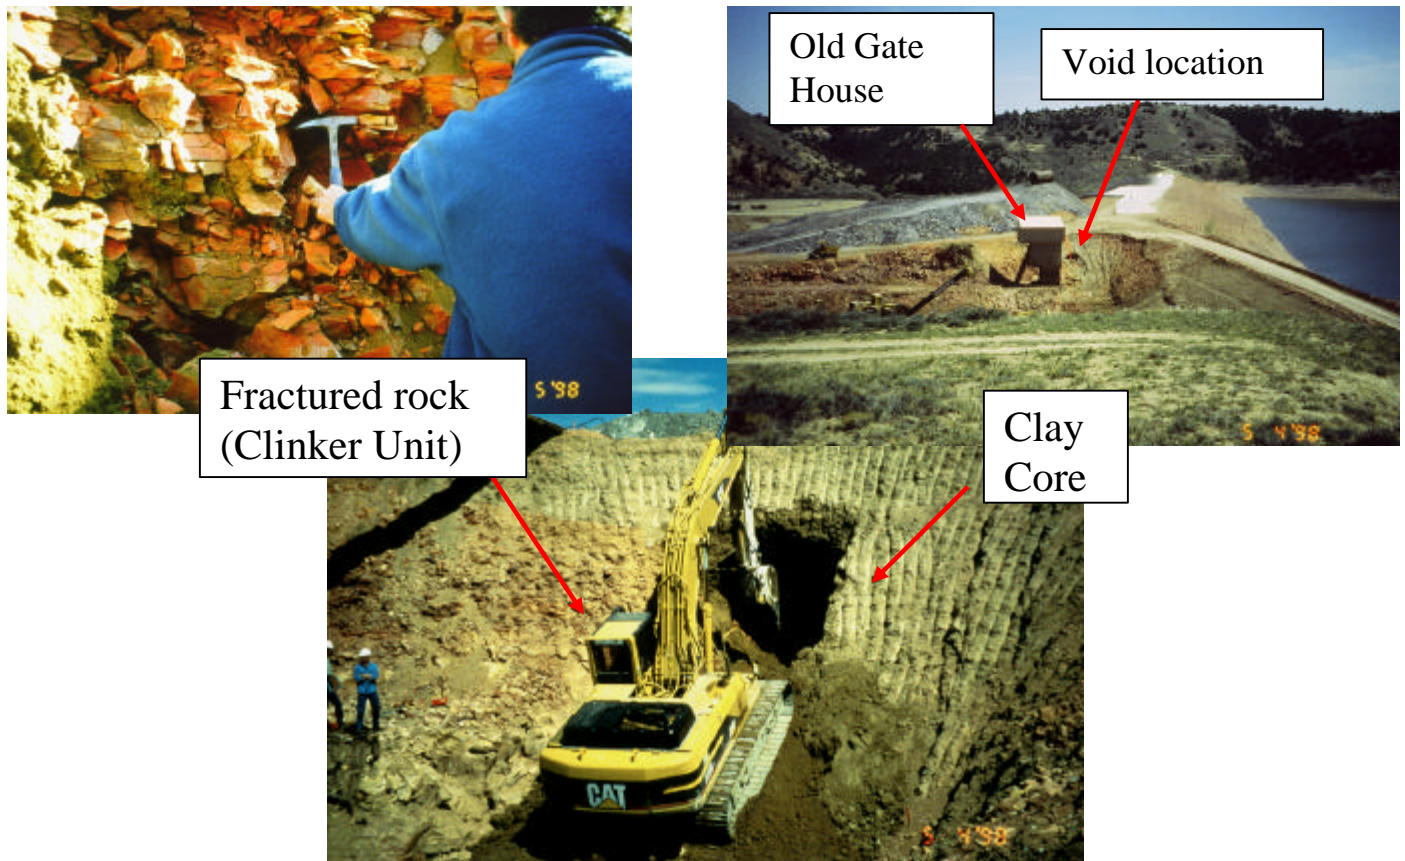
Figure 8. Erosion cavity found at fractured rock interface at Tongue River Dam

The selected remediation concept was to minimize seepage in the vulnerable areas where the fractured rock/clay core contact was unprotected. Seepage at the core/fractured rock contact was minimized using a positive cutoff system comprising a combination of vertical and horizontal seepage barriers. The vertical barrier was a driven, joint-sealed sheet pile wall. The horizontal barriers utilized geomembranes and geosynthetic clay liners (GCLs) that were placed to provide a positive lateral connection between the vertical sheet pile barrier and the spillway structure, and to deflect and reduce seepage flows that overtop the vertical barriers east and west of the spillway. Textured 40 mil, polyethylene geomembrane material was used in front of the spillway, extending partway under the toe of the west closure dam. The geomembrane was underlain by GCL, except in the closure dam area because of slope stability concerns. Geomembrane was selected because of its very low hydraulic conductivity, and the ability to make a relatively water-tight batten connection of this material to the concrete footings and slabs on the spillway structure. The underlying GCL provides a second line of defense in case of geomembrane damage or separation from the structure. GCL also was used east of the right spillway wall (as shown on Figure 9) and at a higher level within the closure dam. GCL was selected for these less critical areas primarily because of its lower cost. More detailed descriptions and drawings of the remediation design elements are presented in the 2001 ASDSO conference proceedings (6).

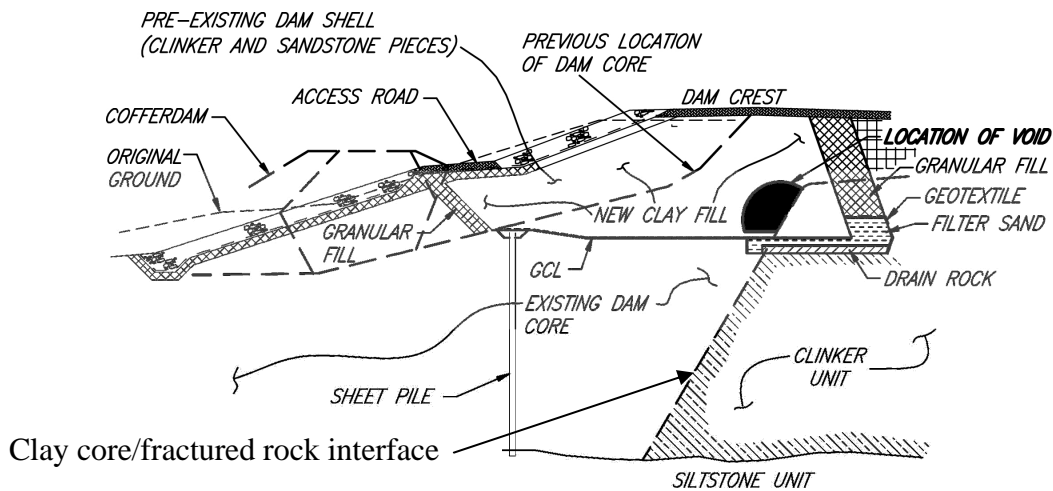
Figure 9. Typical section of cutoff system on right side of primary spillway

The sheet piling was driven completely through the abutment core trench and toed into a tight siltstone unit that underlies the fractured Clinker Unit across the front of the primary spillway, under the west closure dam, and into the far left abutment about 800 feet around the reservoir rim. This pile driving depth criteria was also maintained to the extent possible beyond the right limits of the spillway (towards the dam), as illustrated on Figure 9. However, moving further towards the valley section of the dam from the abutment, the clay core trench broadens and deepens significantly as it cuts off the deep alluvial materials in the Tongue River Valley. The decision was made to stop the pile driving depth above the bedrock, toeing in within the deeper core trench at an elevation below the base of the Clinker Unit. This criteria was a compromise between excavation costs and pile driving depth limitations. Seepage analyses were used to estimate exit gradients at the clay core/fractured rock interface in order to define the required lateral extent of the barrier system into the dam section. Figure 10 illustrates the seepage analyses that were used to guide the lateral extent of the seepage barriers for this end condition.

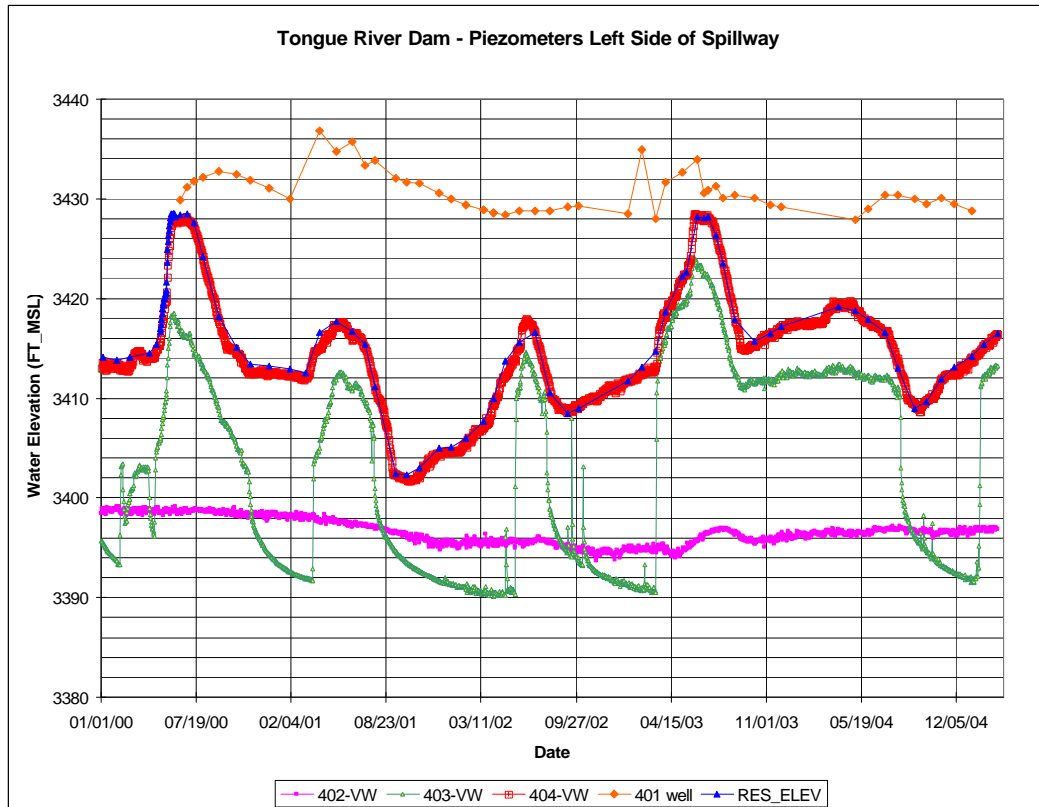
- 401 – located on the crest of the west closure dam (crest elevation 3442.5). This piezometer is an open standpipe with the perforated zone completed in clay fill at elevation 3426.1, above the horizontal GCL barrier. Water elevations in this well are consistently above the reservoir levels, which is very perplexing. The MDNRC has tried bailing the standpipe, but water levels quickly return to high readings.

- 402 – located beneath the upstream slope of the west closure dam. This is a vibrating wire piezometer embedded in clay fill just above the clinker unit contact at elevation 3403.4, beneath the horizontal geomembrane barrier. Pore pressures have remained negative, indicating unsaturated conditions under the barrier at this location.

- 403 - located in the clay-filled core trench upstream from the spillway and downstream from the sheet pile wall, beneath the GCL/geomembrane liner. This is a vibrating wire piezometer embedded near the base of the core trench at elevation 3388.1 in clay fill adjacent to the clinker unit contact. This piezometer appears to be responding to pore pressures in the clinker unit downgradient from the cutoff system. The interpretation is that the clinker unit, which is an intensely fractured rock mass, “fills up” like a drain fed from the exposure of the unit on the reservoir rim west of the barrier. The rapid and extreme rise and fall of pore pressures likely corresponds to filling and drainage of the clinker unit in response to reservoir fluctuations.

- 404 – located in the clay-filled core trench upstream from the sheet pile wall. This is a vibrating wire piezometer embedded at elevation 3388.3 in clay fill adjacent to the clinker unit contact on the upstream side of the core trench. This piezometer closely tracks the reservoir elevations.

Figure 12. Piezometer readings on the west side of the spillway

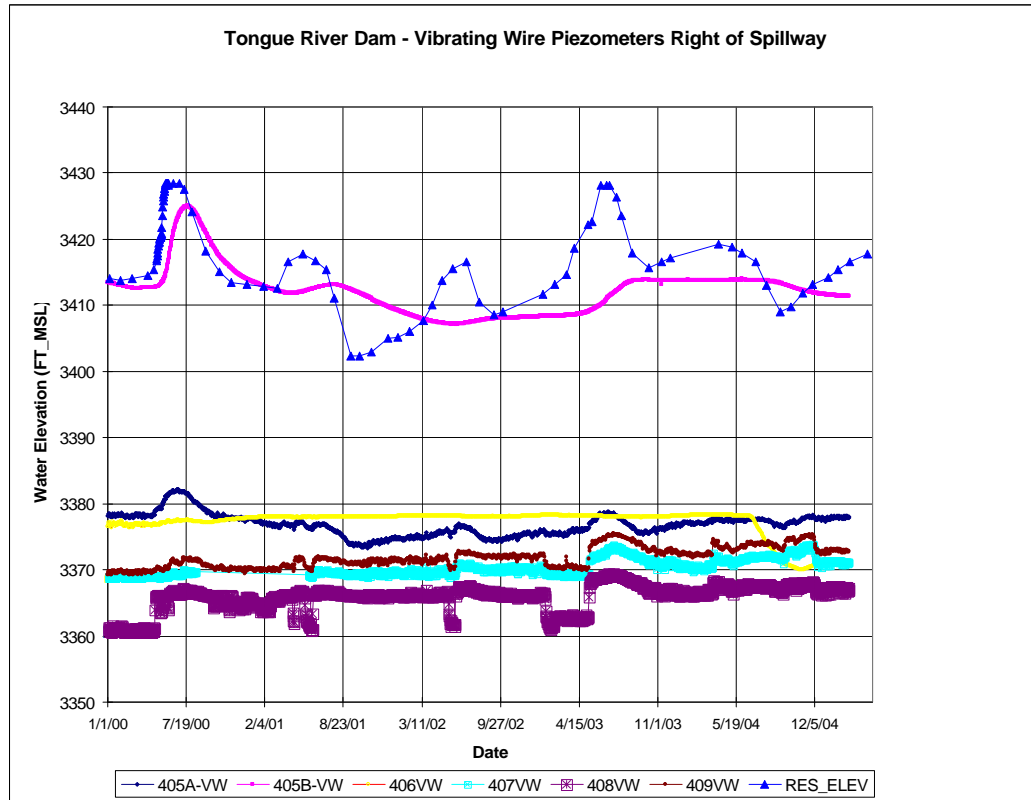
- 405A – located in the clay core trench near the upstream toe of the sheet pile. The sheet pile at this location is toed into the clay fill above the siltstone bedrock (see Figure 10). This instrument is a vibrating wire piezometer embedded in clay core fill at elevation 3369.6, below the elevation of the clinker/siltstone contact. Piezometric readings indicate subdued response to reservoir levels and substantial head loss and downward gradient through the core, when compared to the shallower instrument 405B.

- 405B – located in the clay core trench upstream from the sheet pile and above 405A at elevation 3400.0. Readings indicate pore pressures are generally near reservoir elevations, but that these pore pressures do not completely dissipate or rise to full reservoir levels as the reservoir fluctuates.

- 406 – located in the core trench downstream from the sheet pile wall, above the toe of the pile, and beneath the GCL barrier. This piezometer is situated in clay fill at elevation 3378.6, near the contact between the clinker and siltstone units. This instrument appeared to be non-responsive after its installation in 1999 through about July 2004, when the readings began to drop to elevations below the elevation of the instrument (indicating negative pore pressures).

- 407, 408 and 409 – located in the core of the main dam section, downstream from the sheet pile, and east of the easternmost buried contact limits of the core/fractured rock interface. These piezometers reflect significant head loss is occurring across the broad clay core and very subdued response to reservoir level fluctuations.

Figure 13. Piezometer readings on the east side of the spillway

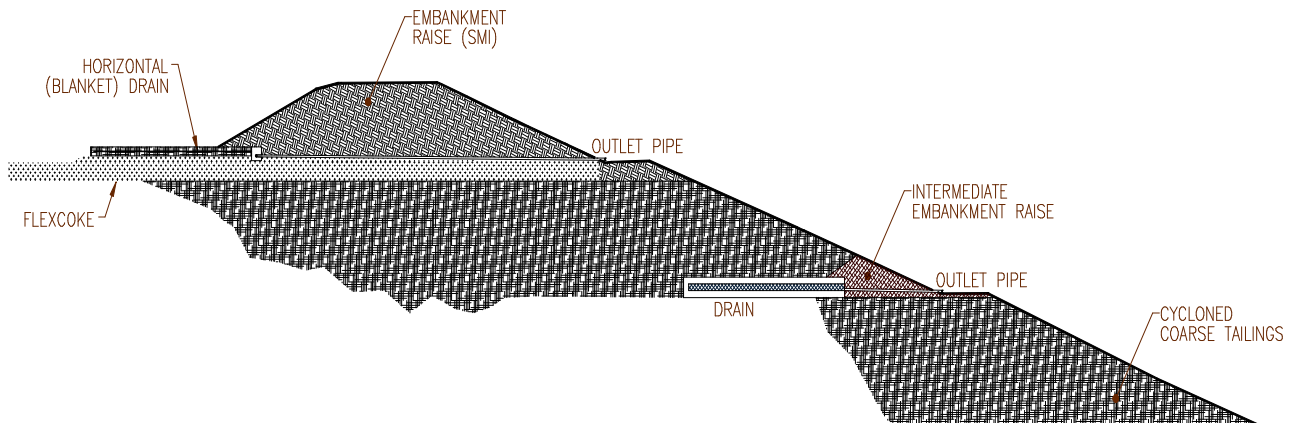
Figure 14. Geocomposite blanket drain used to facilitate downstream raise of a tailings dam

The drain outlets were inspected in November 2001 and a number of the pipes were plugged. The plugged outlets were cleaned and flow from the geogrid drain was re-established. A test pit was excavated in November 2002 on the downstream slope of the dam over one of the outlet pipes, exposing the pipe. The outlet pipe was cleaned out and a remotely operated camera was advanced through it. During cleaning, some tailings, a piece of folded filter fabric and a plastic bottle were flushed from the line. Observations of the line through the camera indicated the line was intact and functional. However, the line had a low point in the grade underneath the embankment such that water would pond in the swale of the pipe, indicating that some settlement had occurred since construction. This particular pipe is located near the maximum section of the dam, as are the only other outlet pipes that have experienced settlement. To date the geogrid drain appears to be functioning as designed, and flows are observed as described above and following precipitation events.
