DAM REHABILITATION USING GEOSYNTHETIC CLAY LINERS

Jim Olsta, P.E. and Don Carine, CETCO

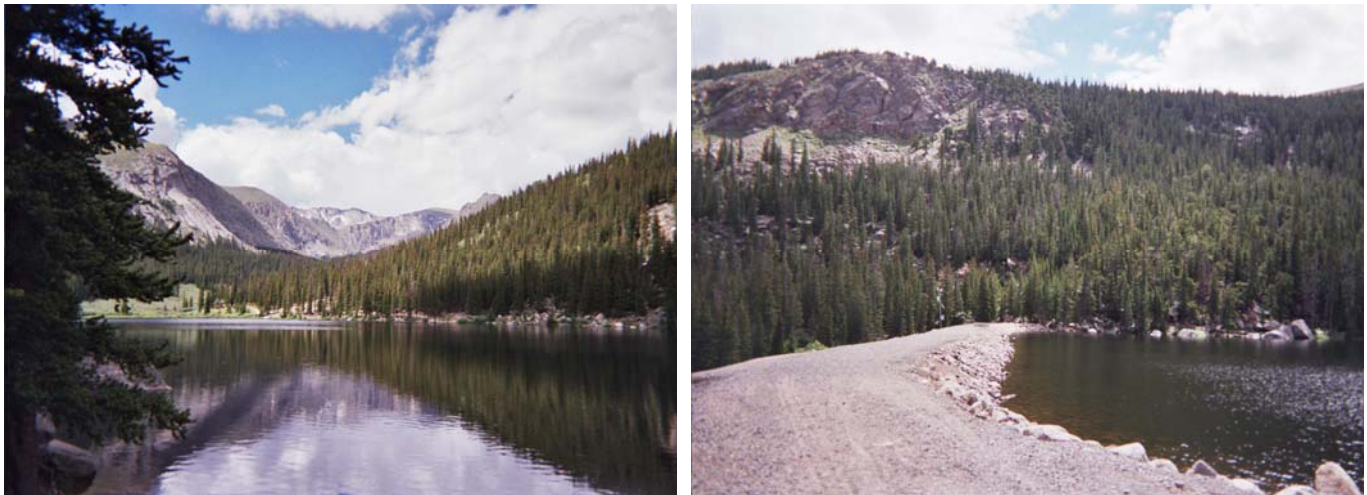
Figures 1a and 1b. Idaho Springs Reservoir and Dam.

The Idaho Springs Reservoir (Figure 1) is located on the eastern front of the Rocky Mountains, 40 miles west of Denver, Colorado. Its primary function is to provide water supply storage for the City of Idaho Springs, Colorado and the surrounding service areas. Built in the early 1900s, an earthen dam controls flooding and protects camp sites and recreation areas in the valley below. By 2000, the Office of the State Engineer, Dam Safety Branch, had placed restrictions on the reservoir's capacity due to the deteriorated condition of the dam and evidence of significant seepage. Prior to the lining project, five significant seepage locations were observed on the downstream side of the dam. One seep exited onto the berm road at the downstream toe (Figure 2) and there was standing water around an observation well located just downstream of the dam. The reservoir capacity is 270 acre-feet at the crest of the

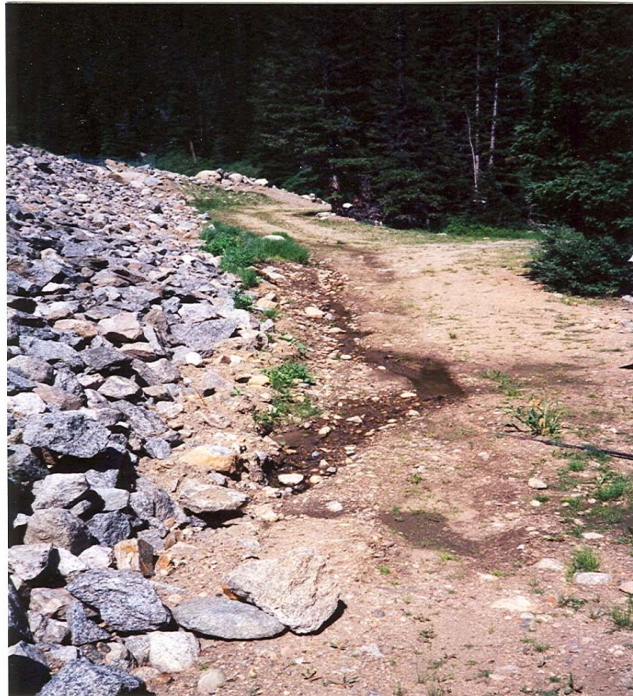
spillway, however, water storage was limited to just 120 acre-feet because of the excessive dam embankment seepage.

Figure 2. Seep at downstream toe of dam prior to rehabilitation

The final approved design called for the placement of a Bentomat[®] CLT geosynthetic clay liner (GCL) along the dam face to the spillway abutment and past the outlet structure. In addition to bentonite clay sandwiched between two geotextiles, Bentomat[®] CLT has a 20 mil HDPE membrane laminated to the outer surface. This provides a composite hydraulic barrier with a maximum hydraulic conductivity of 5×10^{-10} cm/s per ASTM D5887. Direct shear testing was performed between the GCL and the adjacent soils under hydrated conditions per ASTM D5321. The test data indicated a peak friction angle of 45 degrees.

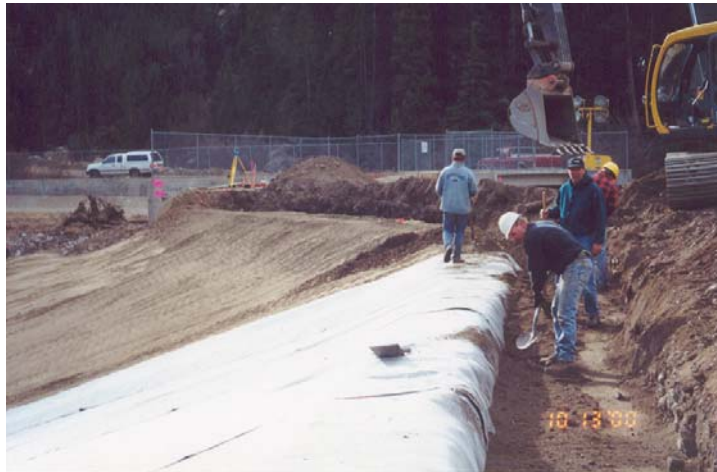
Figure 3. GCL Installation

Repairs to the dam's upstream face began in the fall of 2000 and were completed in the summer of 2001. The GCL was delivered by flatbed truck. Rolls were 15-foot wide with a panel length of 150 feet. The self-sealing ability of the bentonite allowed for a 12-inch panel overlap without the need to weld the geomembrane panels. The GCL panels were anchored into a trench at the crest of the dam and unrolled down the dam face with a backhoe and spreader bar assembly (Figure 3).

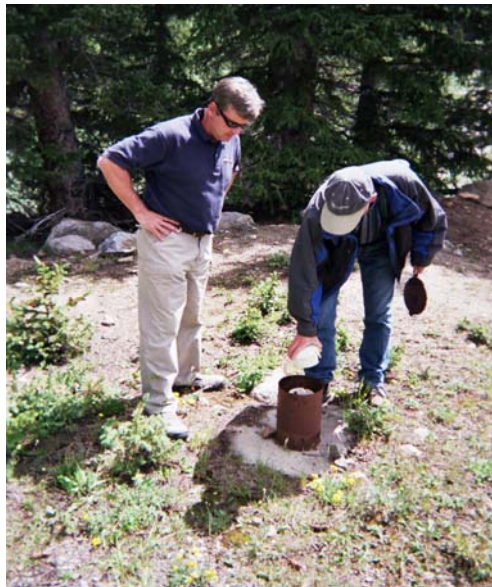
Since the lining project, the downstream toe of the dam has remained dry and water in the observation well just downstream of the dam is 6' below the ground (see Figure 4). Seepage has been greatly reduced to acceptable levels.

Figure 4. Observation well downstream of dam.
