ASDSO
ORLANDO, SEPTEMBER 2005

GEOSYNTHETICS IN DAMS
FORTY YEARS OF EXPERIENCE

J.P. GIROUD

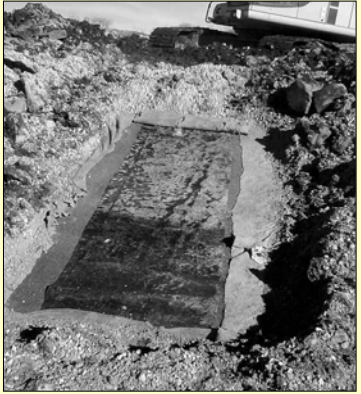
Sample of PVC geomembrane taken from Aubrac Dam

(From coupons placed inside the reservoir under same conditions as in the dam)

- PVC geomembrane from Aubrac Dam**
(1.2 mm thick geomembrane covered with soil)
- Plasticizer loss is limited.
 - Plasticizer loss is greater above water level than below.
 - The rate of plasticizer loss seem to decrease after a few years.
 - Plasticizer loss is about the same for geomembrane below water level and geomembrane in storage.
- and the thickness was only 1.2 mm (47 mils)

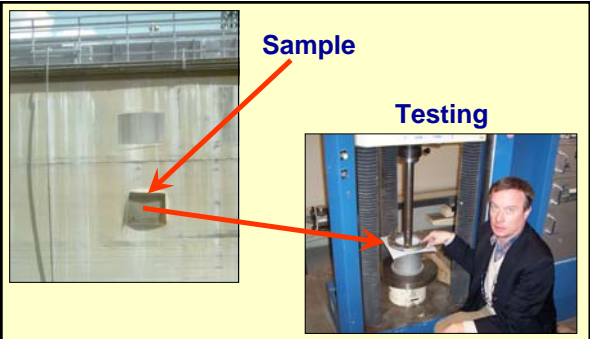
Based on 20 years of testing, a durability of 50 years is predicted.
