# Geosynthetics Applications and Performance Reviews

## Select Case Histories

## Five Case Histories

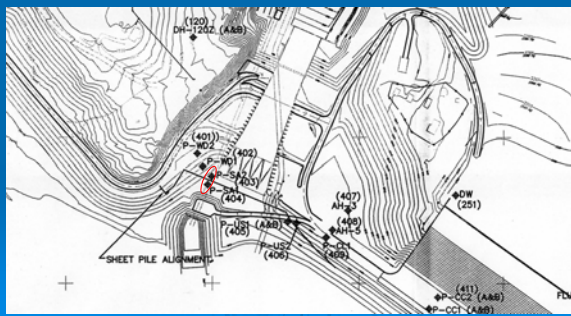
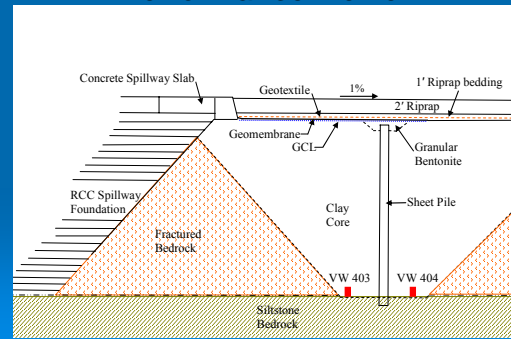
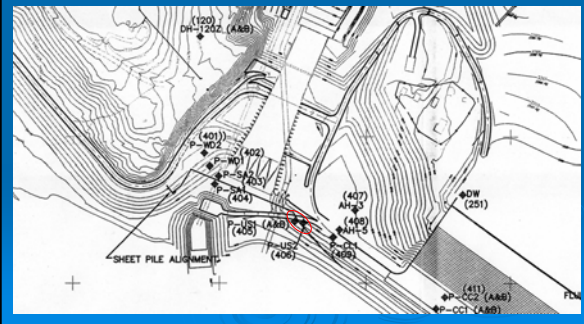
## Tongue River Seepage Barriers Performance Review

- ◆ Piezometric data are inconclusive with regard to barrier performance
  - ◆ “End-around” seepage into the fractured rock unit from west causes rapid rise and fall in water levels as the wedge clinker unit in front of spillway foundation “fills up” then empties. This is being tracked by Piezo 403, and indicates a direct hydraulic connection with the fractured rock unit.
  - ◆ One VW instrument downgradient from the barrier east of spillway (406) may be malfunctioning and needs to be replaced

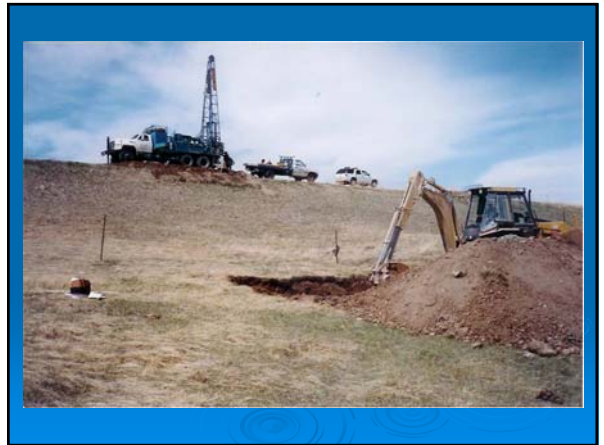
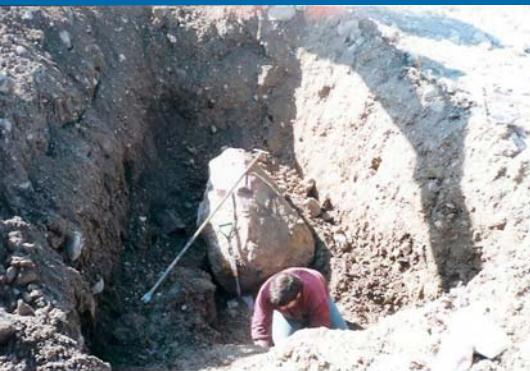
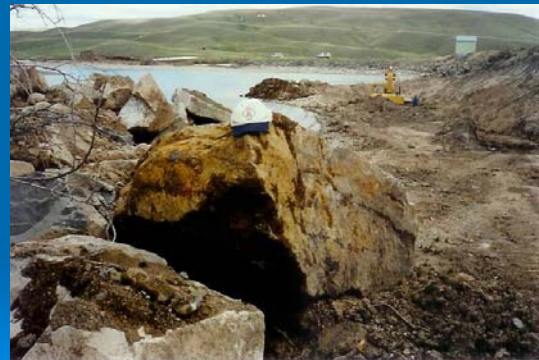
### Partially Excavated “Pipe”

- Depression and piping features were caused by downward erosion of fines from glacial soil matrix into a pocket of openwork boulders and cobbles
- Surficial soils had provided an effective impervious blanket over the area until progressive wave action eroded the natural clay "lining".
- The shallow boulder pocket in the right abutment appeared to be limited in extent, based on the drilling information.

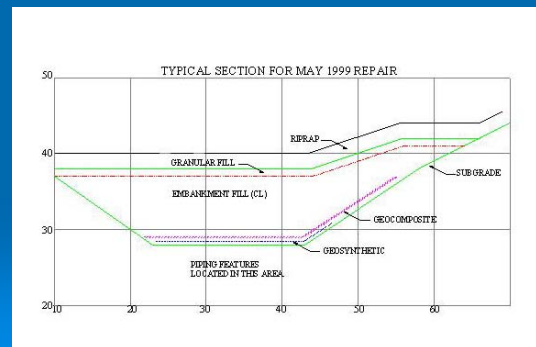
## Selected Remedy,

- ◆ Rapid rise in piezometric levels in summer 1999 following initial repair indicated that the piping features had broken through around the edge of the patch and connected to the gravelly zone at depth
- ◆ After patch was extended in Nov-Dec 1999, piezo monitoring indicates repair seems to be functioning well for past 6 years
