GEOSYNTHETICS APPLICATIONS AND PERFORMANCE REVIEWS – SELECT CASE HISTORIES

Summary

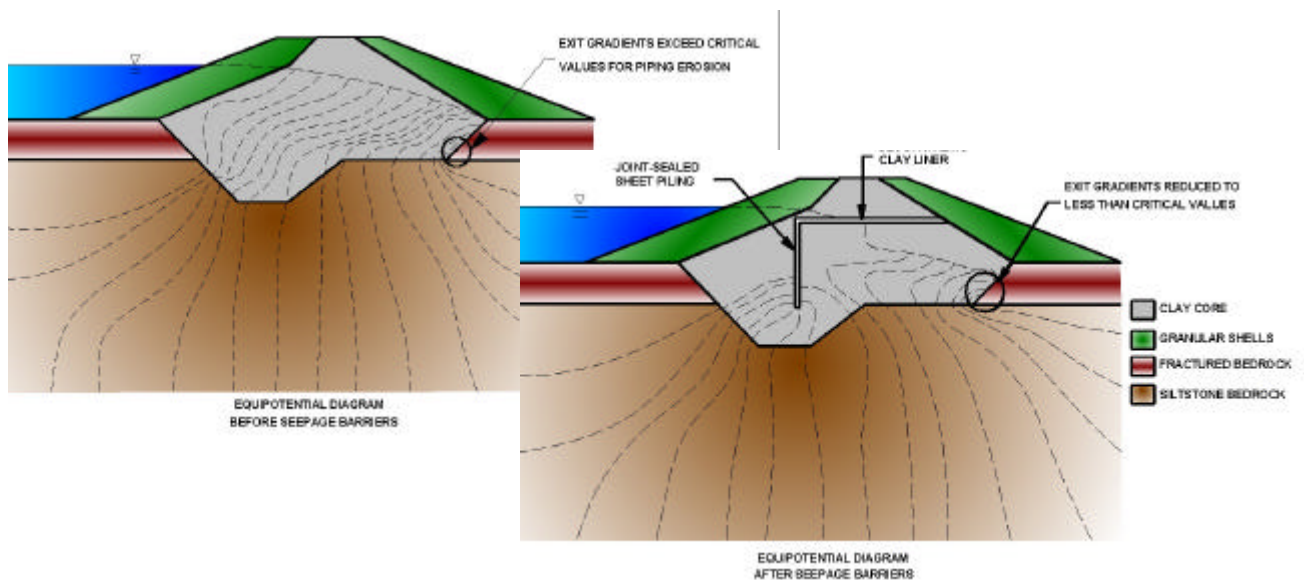
Figure 10. Seepage analysis to define lateral extent of seepage barrier system into dam section

The sheet piling was driven completely through the abutment core trench and toed into a tight siltstone unit that underlies the fractured Clinker Unit across the front of the primary spillway, under the west closure dam, and into the far left abutment about 800 feet around the reservoir rim. This pile driving depth criteria was also maintained to the extent possible beyond the right limits of the spillway (towards the dam), as illustrated on Figure 9. However, moving further towards the valley section of the dam from the abutment, the clay core trench broadens and deepens significantly as it cuts off the deep alluvial materials in the Tongue River Valley. The decision was made to stop the pile driving depth above the bedrock, toeing in within the deeper core trench at an elevation below the base of the Clinker Unit. This criteria was a compromise between excavation costs and pile driving depth limitations. Seepage analyses were used to estimate exit gradients at the clay core/fractured rock interface in order to define the required lateral extent of the barrier system into the dam section. Figure 10 illustrates the seepage analyses that were used to guide the lateral extent of the seepage barriers for this end condition.

- 405A – located in the clay core trench near the upstream toe of the sheet pile. The sheet pile at this location is toed into the clay fill above the siltstone bedrock (see Figure 10). This instrument is a vibrating wire piezometer embedded in clay core fill at elevation 3369.6, below the elevation of the clinker/siltstone contact. Piezometric readings indicate subdued response to reservoir levels and substantial head loss and downward gradient through the core, when compared to the shallower instrument 405B.

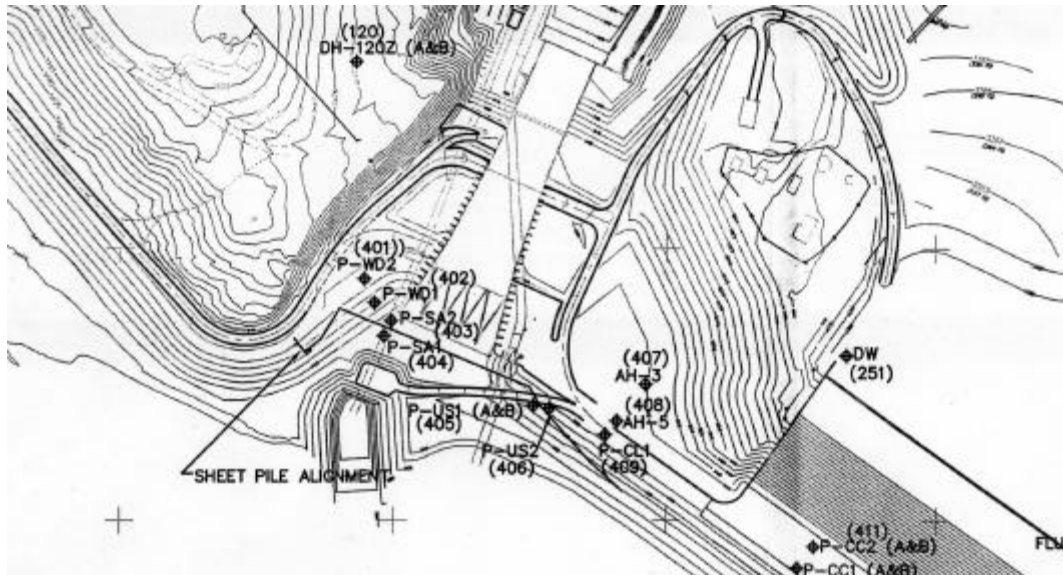
Figure 11. Locations of piezometers in left abutment of Tongue River Dam

Figure 11 shows the location of the sheet pile alignment and piezometers that were installed to monitor the performance of the barrier system. Current piezometer designations are shown in parenthesis. This discussion will focus on piezometers left of the spillway (402, 403 and 404) and right of the spillway (405 through 409).
