Geosynthetics Society

GEOSYNTHETICS SPECIFICATION SAVERS

HDPE Geomembrane **Failures Return** - in Asia

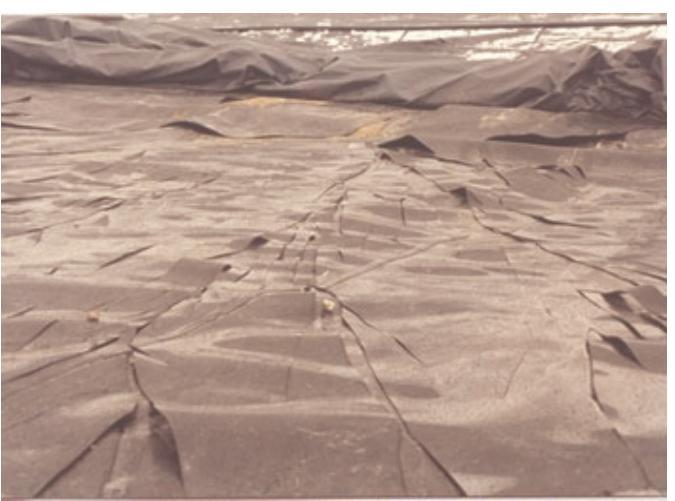
Photo 1, HDPE geomembrane failure in Asia, 2010.

For instance, one can see a clear connection between a photo that I-CORP has from Asia this year (Photo 1) and a 1980s cracking problem in the USA (Photo 2). The USA site was a surface water runoff pond in Boise, Idaho that cracked during a rapid (...continued)

Suggestions from Asia are that the causes of these failures are local manufacturers using recycled HDPE; insufficient carbon black in the formulations; insufficient OIT (under 10 minutes); or poor resins.

The RCP shattering is spectacular but is typically initiated at Slow Crack Growth (SCG) stress cracks when they achieve a critical geometry and growth rate, such as might be caused by contraction stresses during rapidly decreasing temperatures. If the SCG can be identified and repaired during routine visual inspections, the RCP can be avoided.

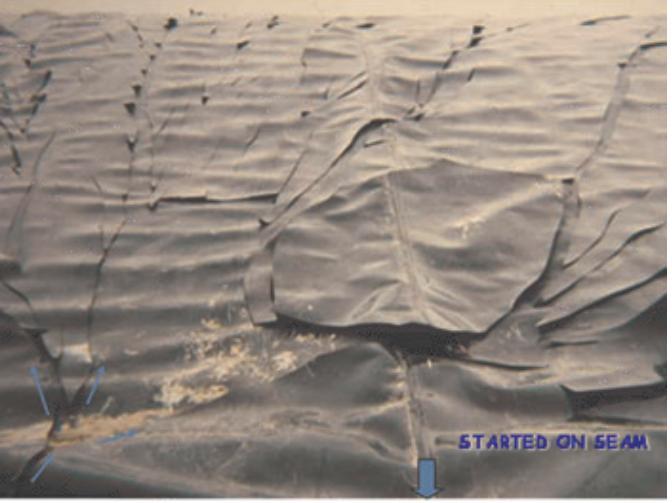
Photo 2, HDPE failure in the USA, 1980s.

BENEFACTOR MEMBERS (IN ORDER OF JOINING) Engineered Linings • Kaytech • Aquatan • Geotextiles Africa • SRK Consulting • Jones & Wagener • Du Pont South Africa Gundle Geosynthetics • ARQ Consulting Engineers • Reinforced Earth South Africa • Maccaferri South Africa • Gast • Safyr decrease in temperature. The failure initiated at an overheated section of a fusion seam that had been overlain by an extrusion bead.

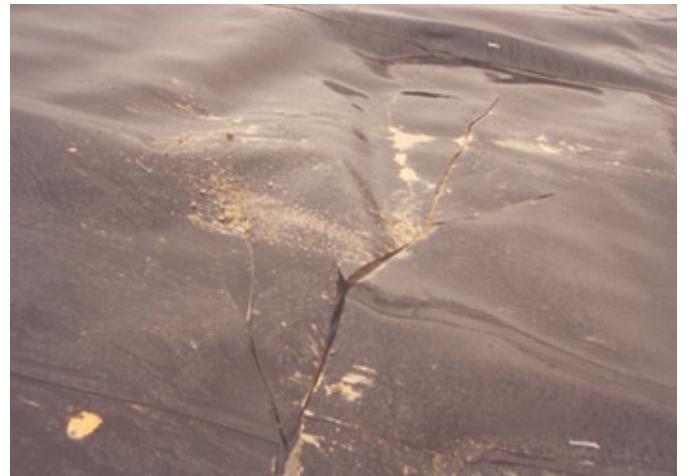
Photo 3, HDPE geomembrane failure in Asia, 2010.

The second pair of photographs shows an Asian failure (Photo 3) compared to a more recent SC failure along and close to a seam in an unreinforced PP geomembrane on the slopes of a wastewater treatment plant (WWTP) pond (Photo 4).

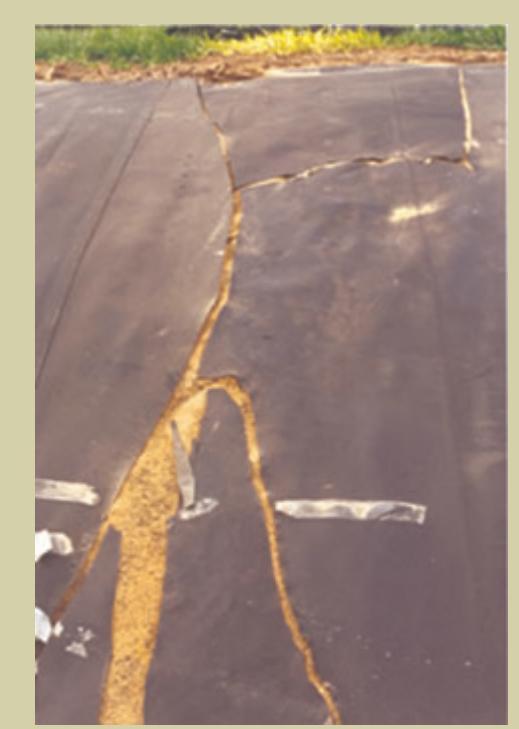
Photo 4, PP failure in USA, circa 1993.

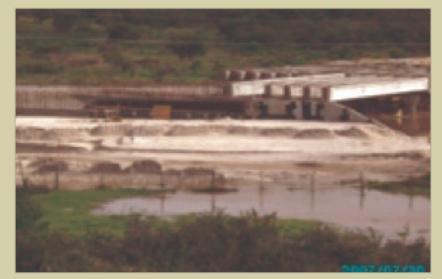
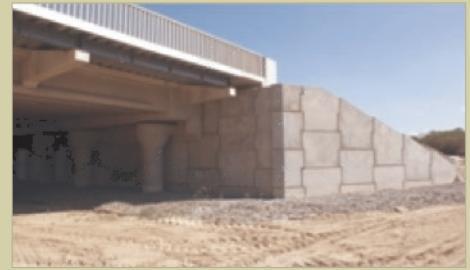
False bridge abutment at Diep Rivier which maintained its integrity during a flood while under construction.

Shown below are two examples of what might be described as composite structures. With the use of steel and concrete forming a discrete panel, combined with layers of Polymeric reinforcement and soil and filter fabric as the moisture and soil migration barrier, these structures serving, within hydraulic conditions were built and perform as designed.

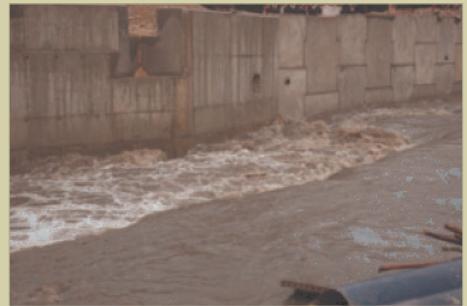
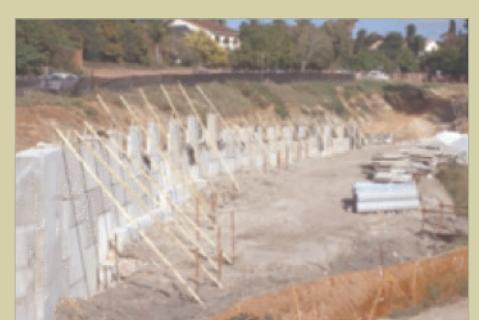
Retaining Wall at Kragga Kamma in Port Elizabeth which sustained the normal rainfall river flow conditions while under construction. The wall has sufficient scour protection for normal flow and is able to cope with 1 in 100 year flooding.

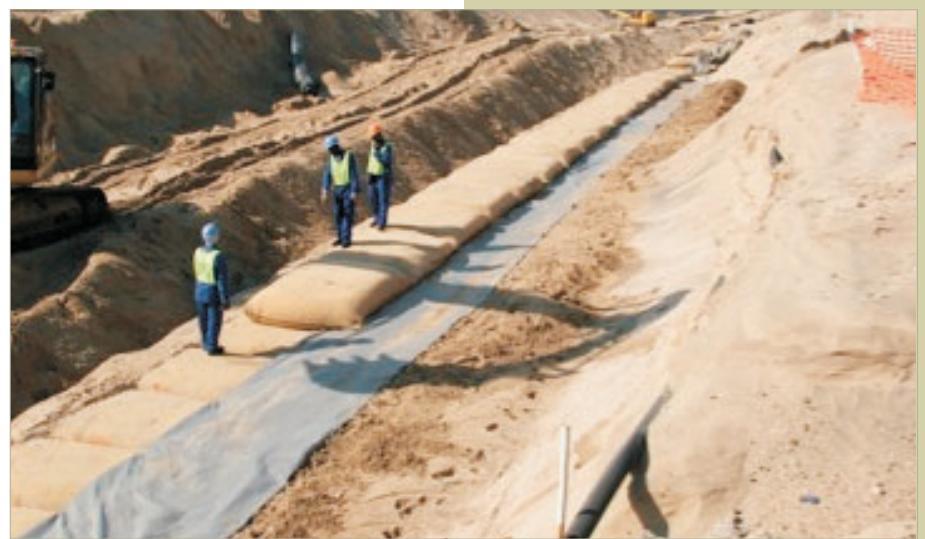
Photo 2: Single Layer of EnviroRock[™] with RockGrid[®] PC wrap around wall

Kaytech's geocontainers have proved integral in work on repairing the beaches after the March 2007 storms in KZN. In addition, they have proved their effectiveness in two major groynes constructed to help restore Langebaan's beaches after severe storm damage. These measures have been successful further afield in Australia and in many other parts of the world. A further benefit is that these solutions fit hand in glove with the Department of Environmental Affairs' requirement for "soft solutions "wherever possible. The design entailed the use of 3.5 ton to 4 ton geocontainers. The wall was constructed using a double layer of these containers (i.e. one bag behind the other) for the full height of the protection at a slope of 1:1. In addition, provision was made for a flexible front toe that protrudes out from the main structure, commonly referred to as a "Dutch toe" or "self healing toe" for scour mitigation. The financial constraints of the client had to be considered, therefore, the area immediately in front and some distance either side of buildings was protected with a double layer of geocontainers whilst the remainder of the promenade was protected with a single layer and a two meter high RockGrid[®] PC 100/100 geogrid wrap around wall.

The geogrid referred to is a high tensile strength composite polyester grid combined with a lightweight, needlepunched, nonwoven, polyester geotextile that provides excellent reinforcing characteristics and ensures minimum deformation in the structure. As a composite reinforcing grid, the geotextile component provides sufficient drainage capacity within its plane, i.e. transmissivity, enabling it to reduce pore pressure buildup in the reinforced soil, thereby improving the internal shear resistance and overall stability of the structure.

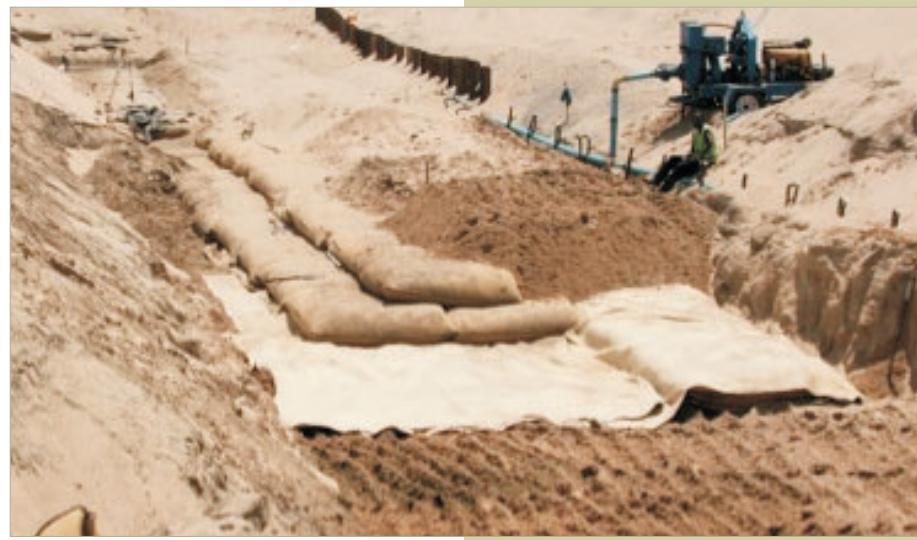
Photo 3: Double layer EnviroRock[™] Wall

EnviroRock^(R) geocontainers are specifically designed for the projects where they are used, and manufactured from a robust, durable nonwoven staple-fibre polypropylene material which is UV stabilized and abrasion resistant making it well suited to coastal erosion control applications. The systems, designed with input from Kaytech, are effective, and an aesthetic solution that assimilates well into the environment.
