The GeoRidge News

GeoRidge Installed on I-94 in Michigan

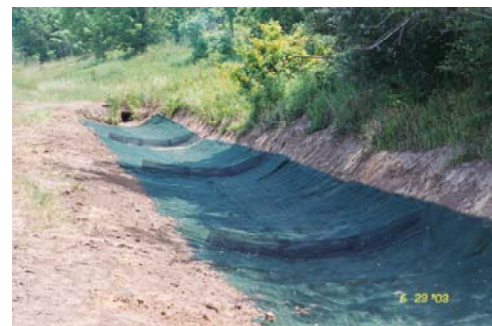
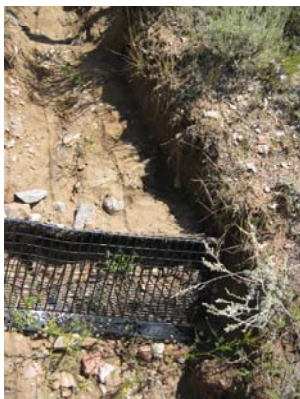
High storm water volume and no established vegetation combined to cause heavy erosion in a 250 foot section of drainage ditches along the south side of this a section of heavily traveled I-94 near Lawrence, Michigan.

The high storm water volume and velocity were due to runoff concentrated from a highway overpass embankment directly upstream, and the erosion was compounded by the sandy soil at the site.

The solution required reducing the water velocity in the ditch, protecting the soil from further erosion and allowing vegetation to establish, and reinforcing the vegetation once it establishes. GeoRidge, the original, patented ditch berm, and an appropriate Turf Reinforcement Mat were utilized together to protect the soil from further erosion and to allow vegetation to establish. CSI/Geoturf, the GeoRidge distributor in Michigan, worked with the Michigan Department of Transportation on the I-94 project. (Thank you to Dan Smith of CSI/Geoturf for providing the excellent photos and text for the case study.)

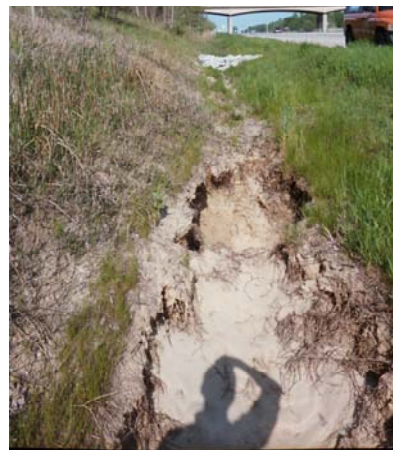
Although not a typical application (no erosion control blanket was used), GeoRidge was installed here to aid in the reduction of channel erosion that had already started. The GeoRidge has not been undermined and the installer is happy with the sediment that is being prevented from going downstream.

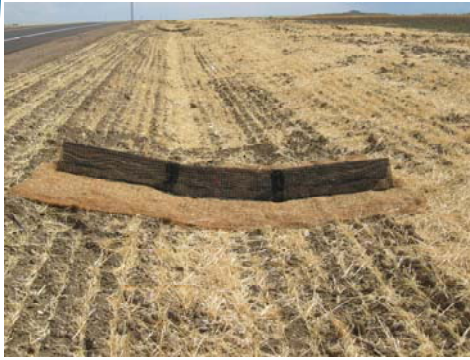
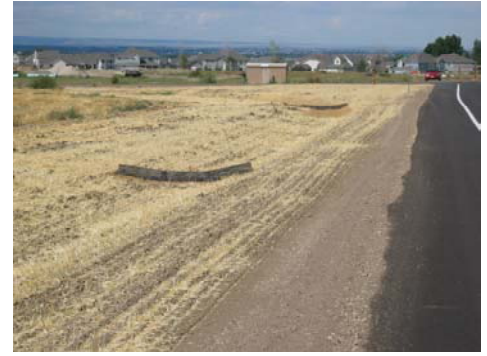
GeoRidge installed on Blanket Strips

Larimer County, Colorado, installed GeoRidge in the road side ditch of CO Highway 5. As they didn't want to place erosion control blanket (ECB) in the entire channel, ECB strips were placed under the GeoRidge. The strips were ~ 3 foot wide. Blown and crimped straw was placed in areas not covered by GeoRidge and ECB's.

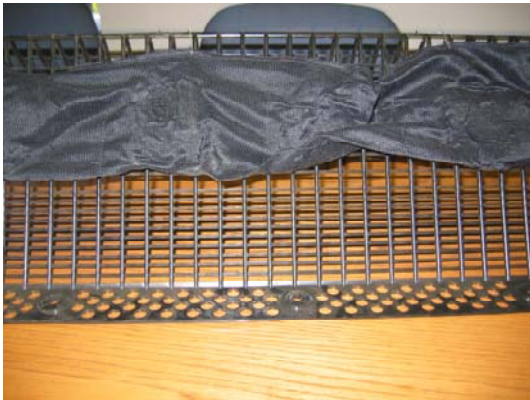
The Federal Highway Administration (FHWA) is currently drafting a request for proposal for a chitosan best management practices guidelines. Chitosan is a natural biopolymer derived from crab and shrimp shells. In turbid water, chitosan causes coagulation of sediment particles which then allows for gravity settling, biofiltration, sand filtration, or cartridge filtration.

Nilex has been working with the FHWA and the GeoRidge / chitosan combination included in the BMP guidelines. A picture of the GeoRidge and Natural Site Solutions Gel-Floc is shown above.

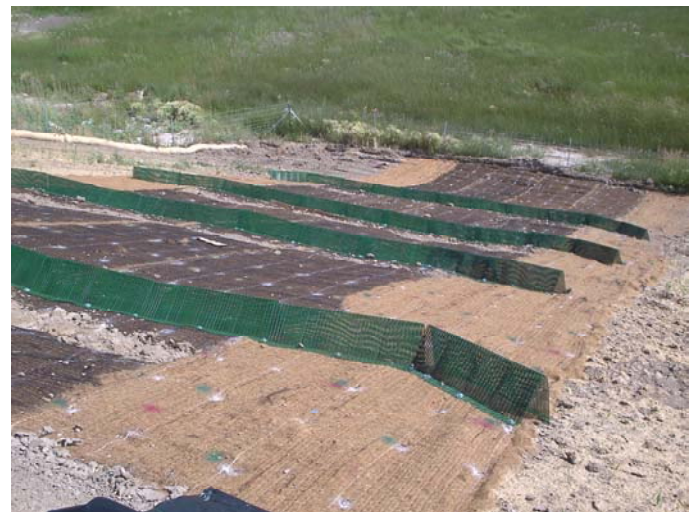
E-470 Off Ramp – Colorado
Installed on coconut and straw coconut blanket
